SCOSS and CROSS

### SCOSS Alert | May 2019

# FAILURE OF REINFORCED AUTOCLAVED AERATED CONCRETE (RAAC) PLANKS

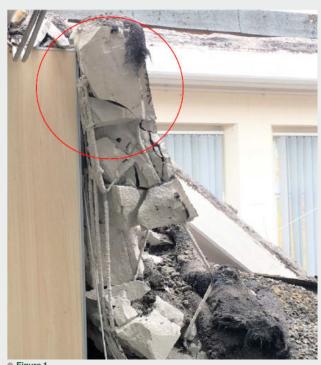
Figure 1 The 2018 roof slab collapse

In the case of the 2018 failure, there was evidence of shear cracking adjacent to a support and possible indications of tension reinforcement stopping short of the support. It was noted during investigation that the roof had been recently resurfaced. Also, the failure was at a time of hot weather, so there may have been a thermal influence.

In the case of the 2018 failure, there was evidence of shear cracking adjacent to a support and possible indications of tension reinforcement stopping short of the support.

Sight must not be lost of the fact that the 2018 collapse was sudden with very little noticeable warning. This is indicative of shear failure in cementitious materials and can only be protected against by knowing that there is sufficient shear resistance in the material, the reinforcement, or both.

Pre-1980 RAAC planks are now past their expected service life and it is recommended that consideration is given to their replacement.

There is therefore a risk, although its extent is uncertain. The risk must be identified by locating buildings where RAAC planks are present and assessing their condition and structural adequacy. If there is doubt about the structural adequacy of the planks, then it is recommended that consideration is given to their replacement.

If there is doubt about the structural adequacy of the planks and/or there is evidence of water ingress, then it is recommended that consideration is given to their replacement.
