SCOSS

SCOSS Alert | May 2019

FAILURE OF REINFORCED AUTOCLAVED AERATED CONCRETE (RAAC) PLANKS

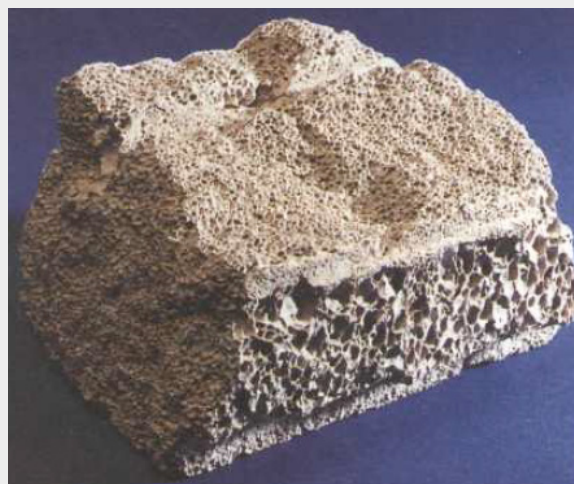
Autoclaved aerated concrete (AAC) is different from normal dense concrete. It has no coarse aggregate, and is made in factories using fine aggregate, chemicals to create gas bubbles, and heat to cure the compound. It is relatively weak with a low capacity for developing bond with embedded reinforcement. It was used in two main forms of structural elements; lightweight masonry blocks and structural units (such as roof planks, wall and floor units).

● Figure 2
A lump sample of AAC ^[1]
